Acoustic Thermometry of Ocean Climate (ATOC): Pioneer Seamount Source Installation

Technical Memorandum

APL-UW TM 3-96

April 1996

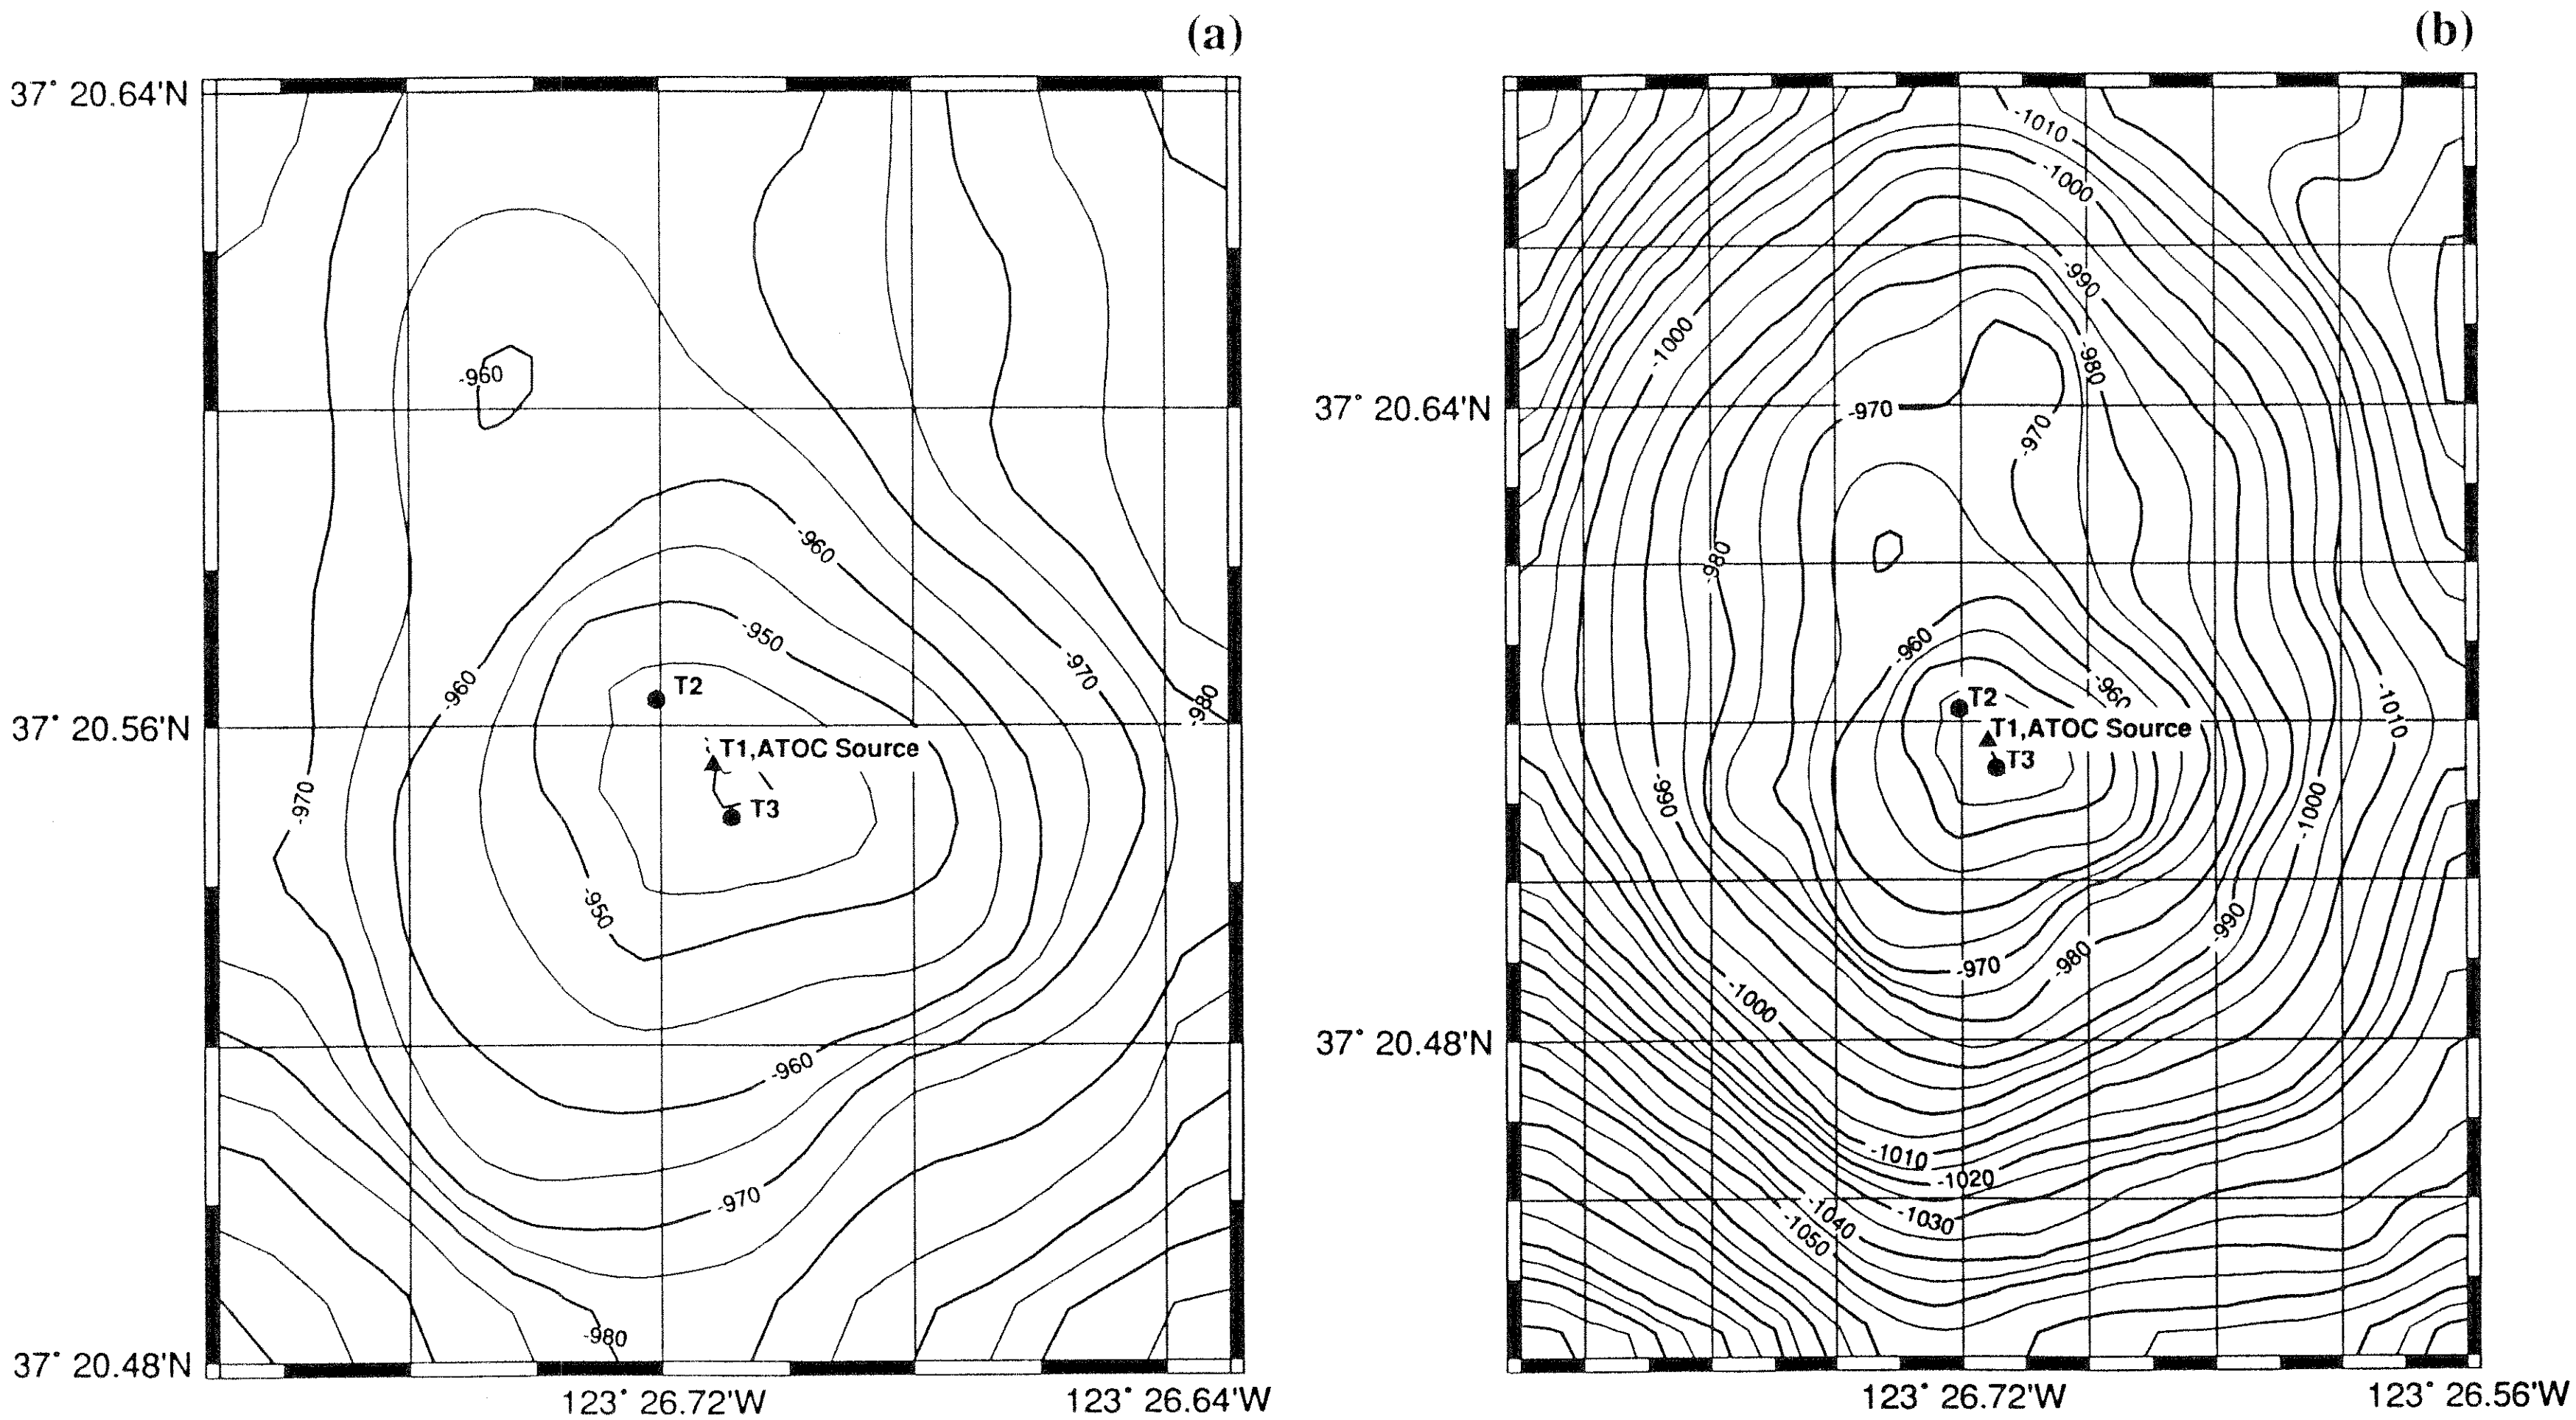
Cliff observations. Figure 13 shows a guesstimate of the position of the source relative to the high-resolution bathymetry, based on the *Sea Cliff* observations that T1 was about 5 m east of the west edge, that T2 was on the northwest slope 5 m deeper than T1, and that T3 was about 4 m deeper than T1 and to the southeast.

Figure 13. Charts showing the source and transponder locations. The bathymetry is from the 120-kHz data (Figure 10), shifted vertically to match the measured transponder depths and shifted horizontally so the absolute position of Transponder 1 (and the source Love Point) qualitatively matches the *Sea Cliff* observations of topography. Each grid box is 60 m by 74 m (east by north). (Machine-contouring artifacts are present at the middle of each edge.) (a) Just the peak of the seamount. (b) The peak including the flanks.

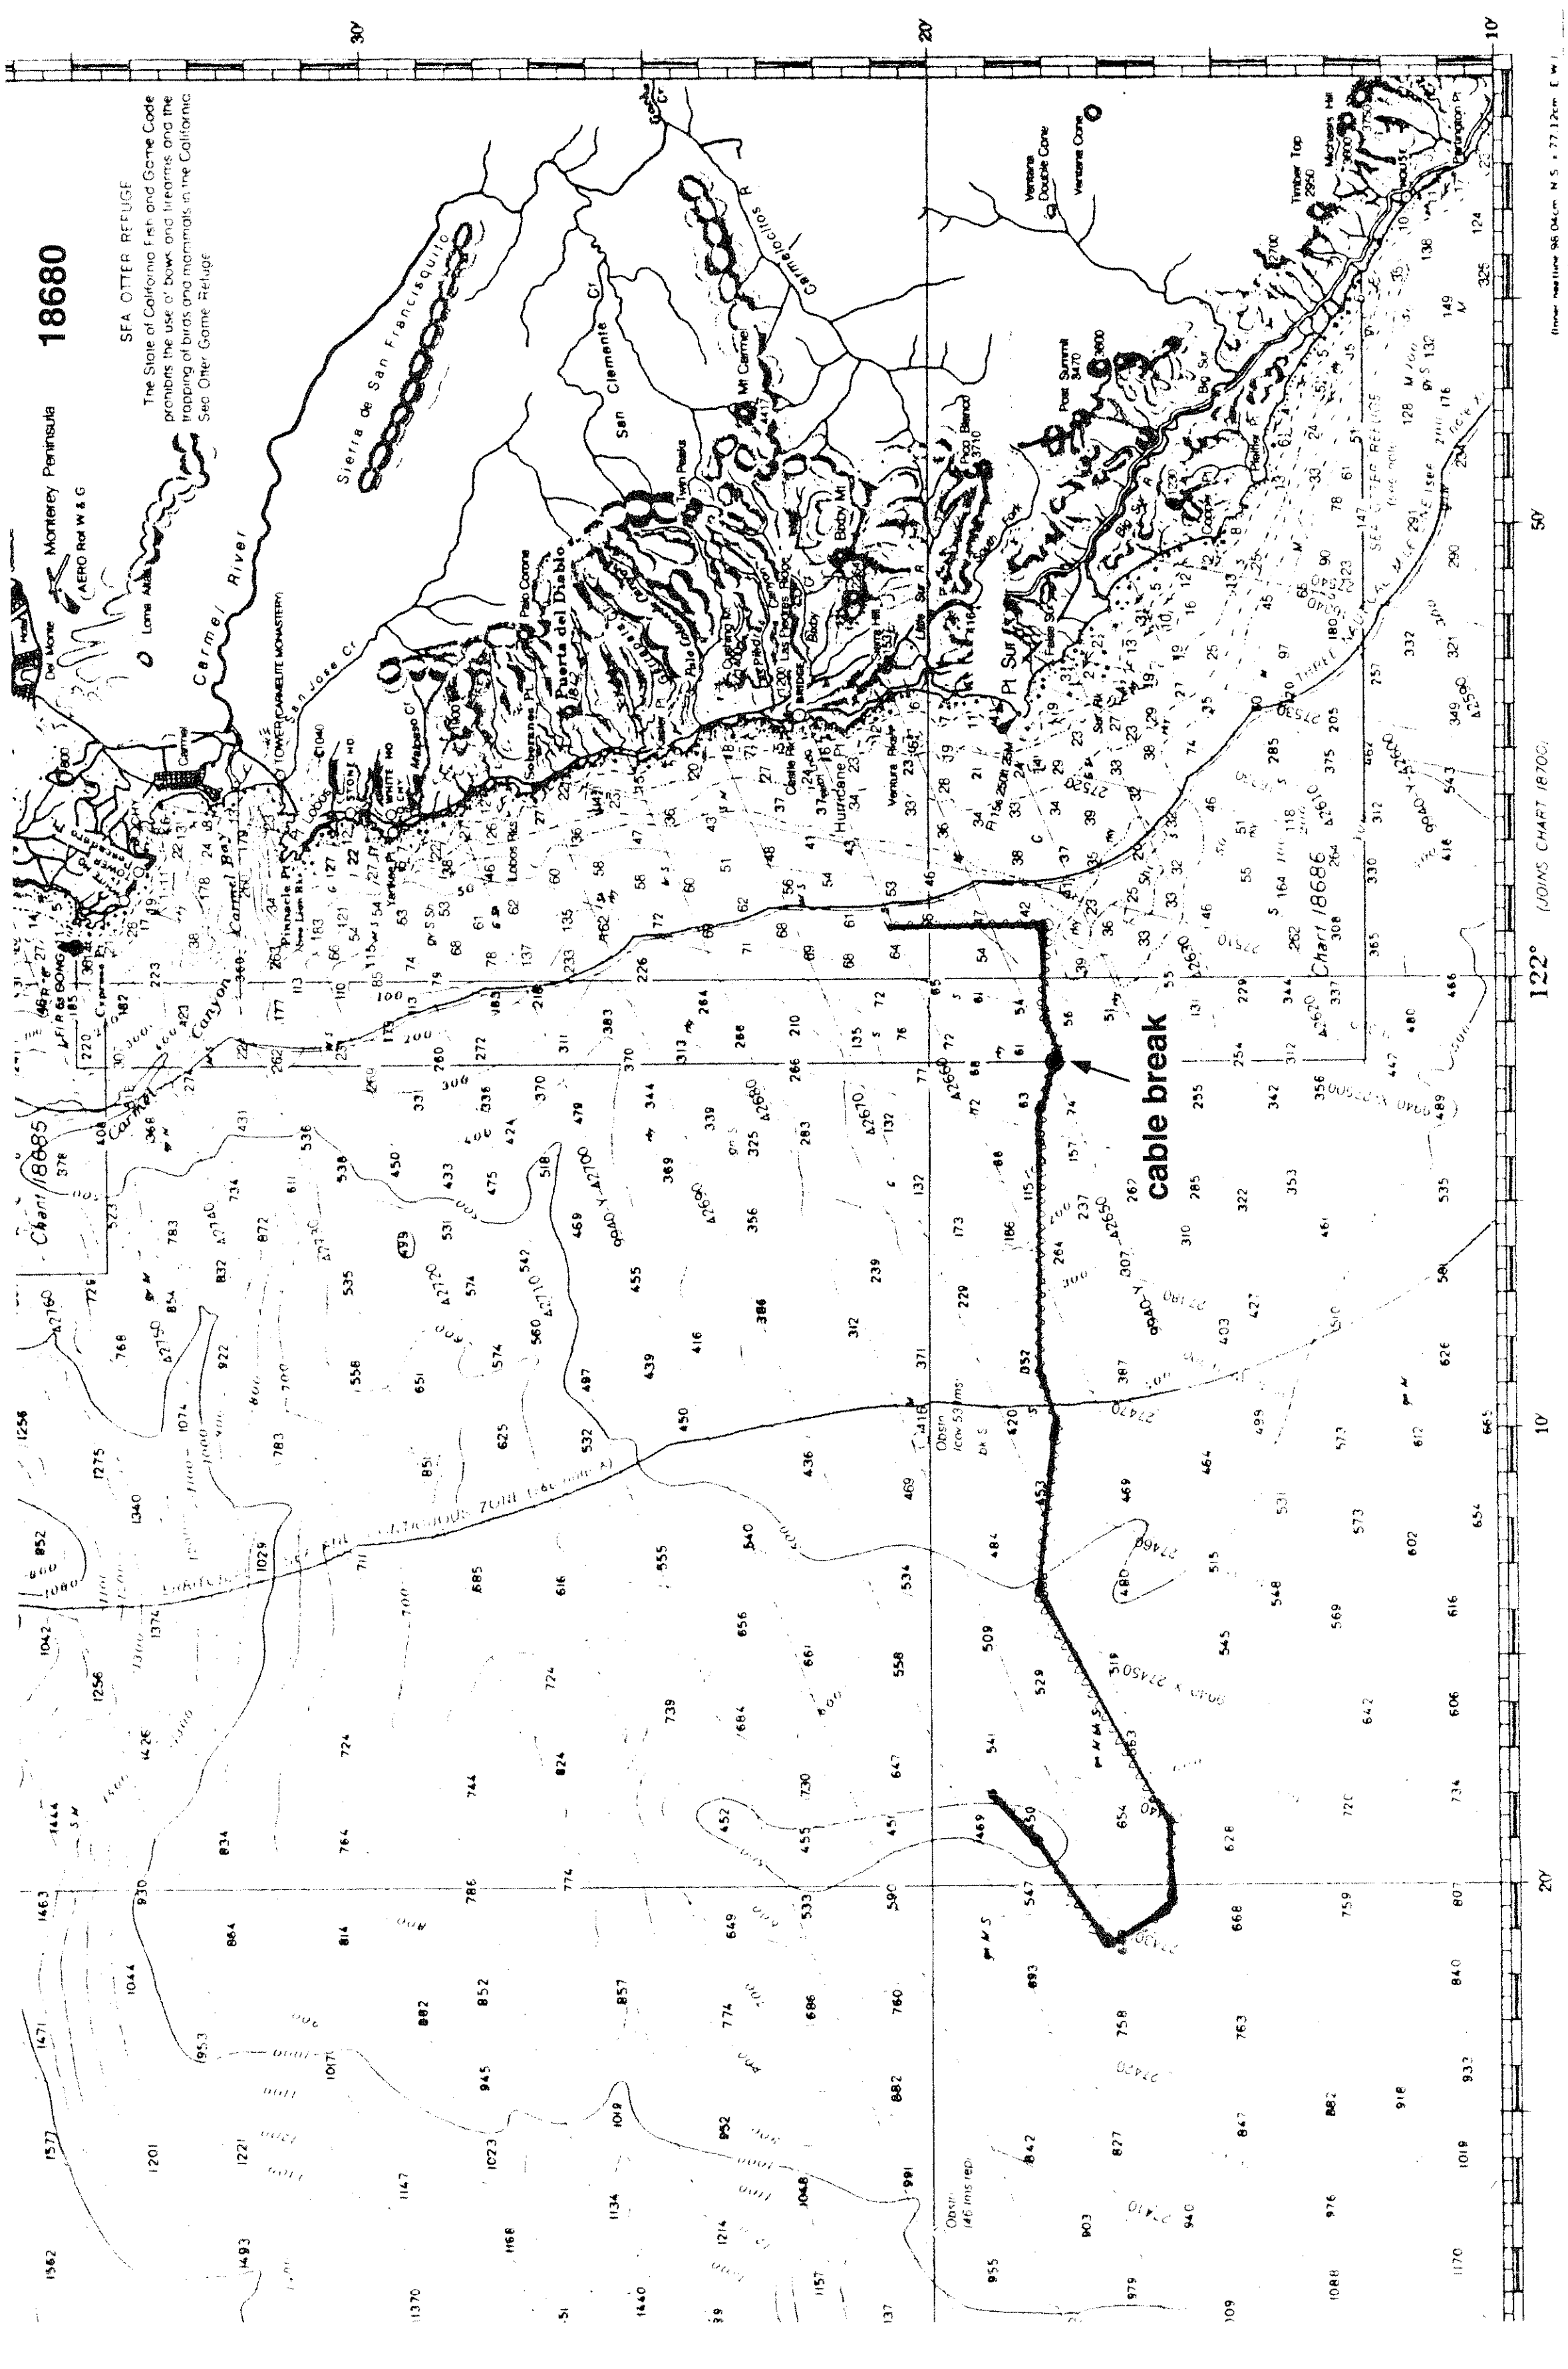
Figure 20. Point Sur cable route. The point the break was found is indicated.

F/V *Point Loma* had caught the cable in its trawl gear on 13–14 September 1995 at 36°17.91′N, 122°1.92′W in 108 m of water approximately 5.8 nmi from the landward end of the cable. *Point Loma* personnel reported that the outer jacket and shield were cut through but that the center strength member was intact when cable was thrown back. (By coincidence, the *Point Loma* was also in the area during the cable recovery and an interesting conversation took place.) The cable was found parted. It had failed under tension (as evidenced by wires that were necked down) prior to recovery (as evidenced by corrosion). At one place, it was obvious that wire rope had sawed into the SD cable in a spiral fashion, cutting through the conductors to the center steel strength wires. After the shoreward section was recovered, the acoustic release on the seaward end was triggered and the cable recovered. About 2 nmi of cable was damaged and was removed before splicing the two lengths together. The termination on the end of the Point Sur cable was tested and spliced onto the opposite end of the cable.

The Point Sur cable had many cuts and gouges, maybe from contact with rocks on recovery. There were obvious wire rope marks near the break. The break was due to failure in tension as evidenced by the necked down steel wires. Approximately TDR 2675 m of bad cable were cut off from the recovered cable.

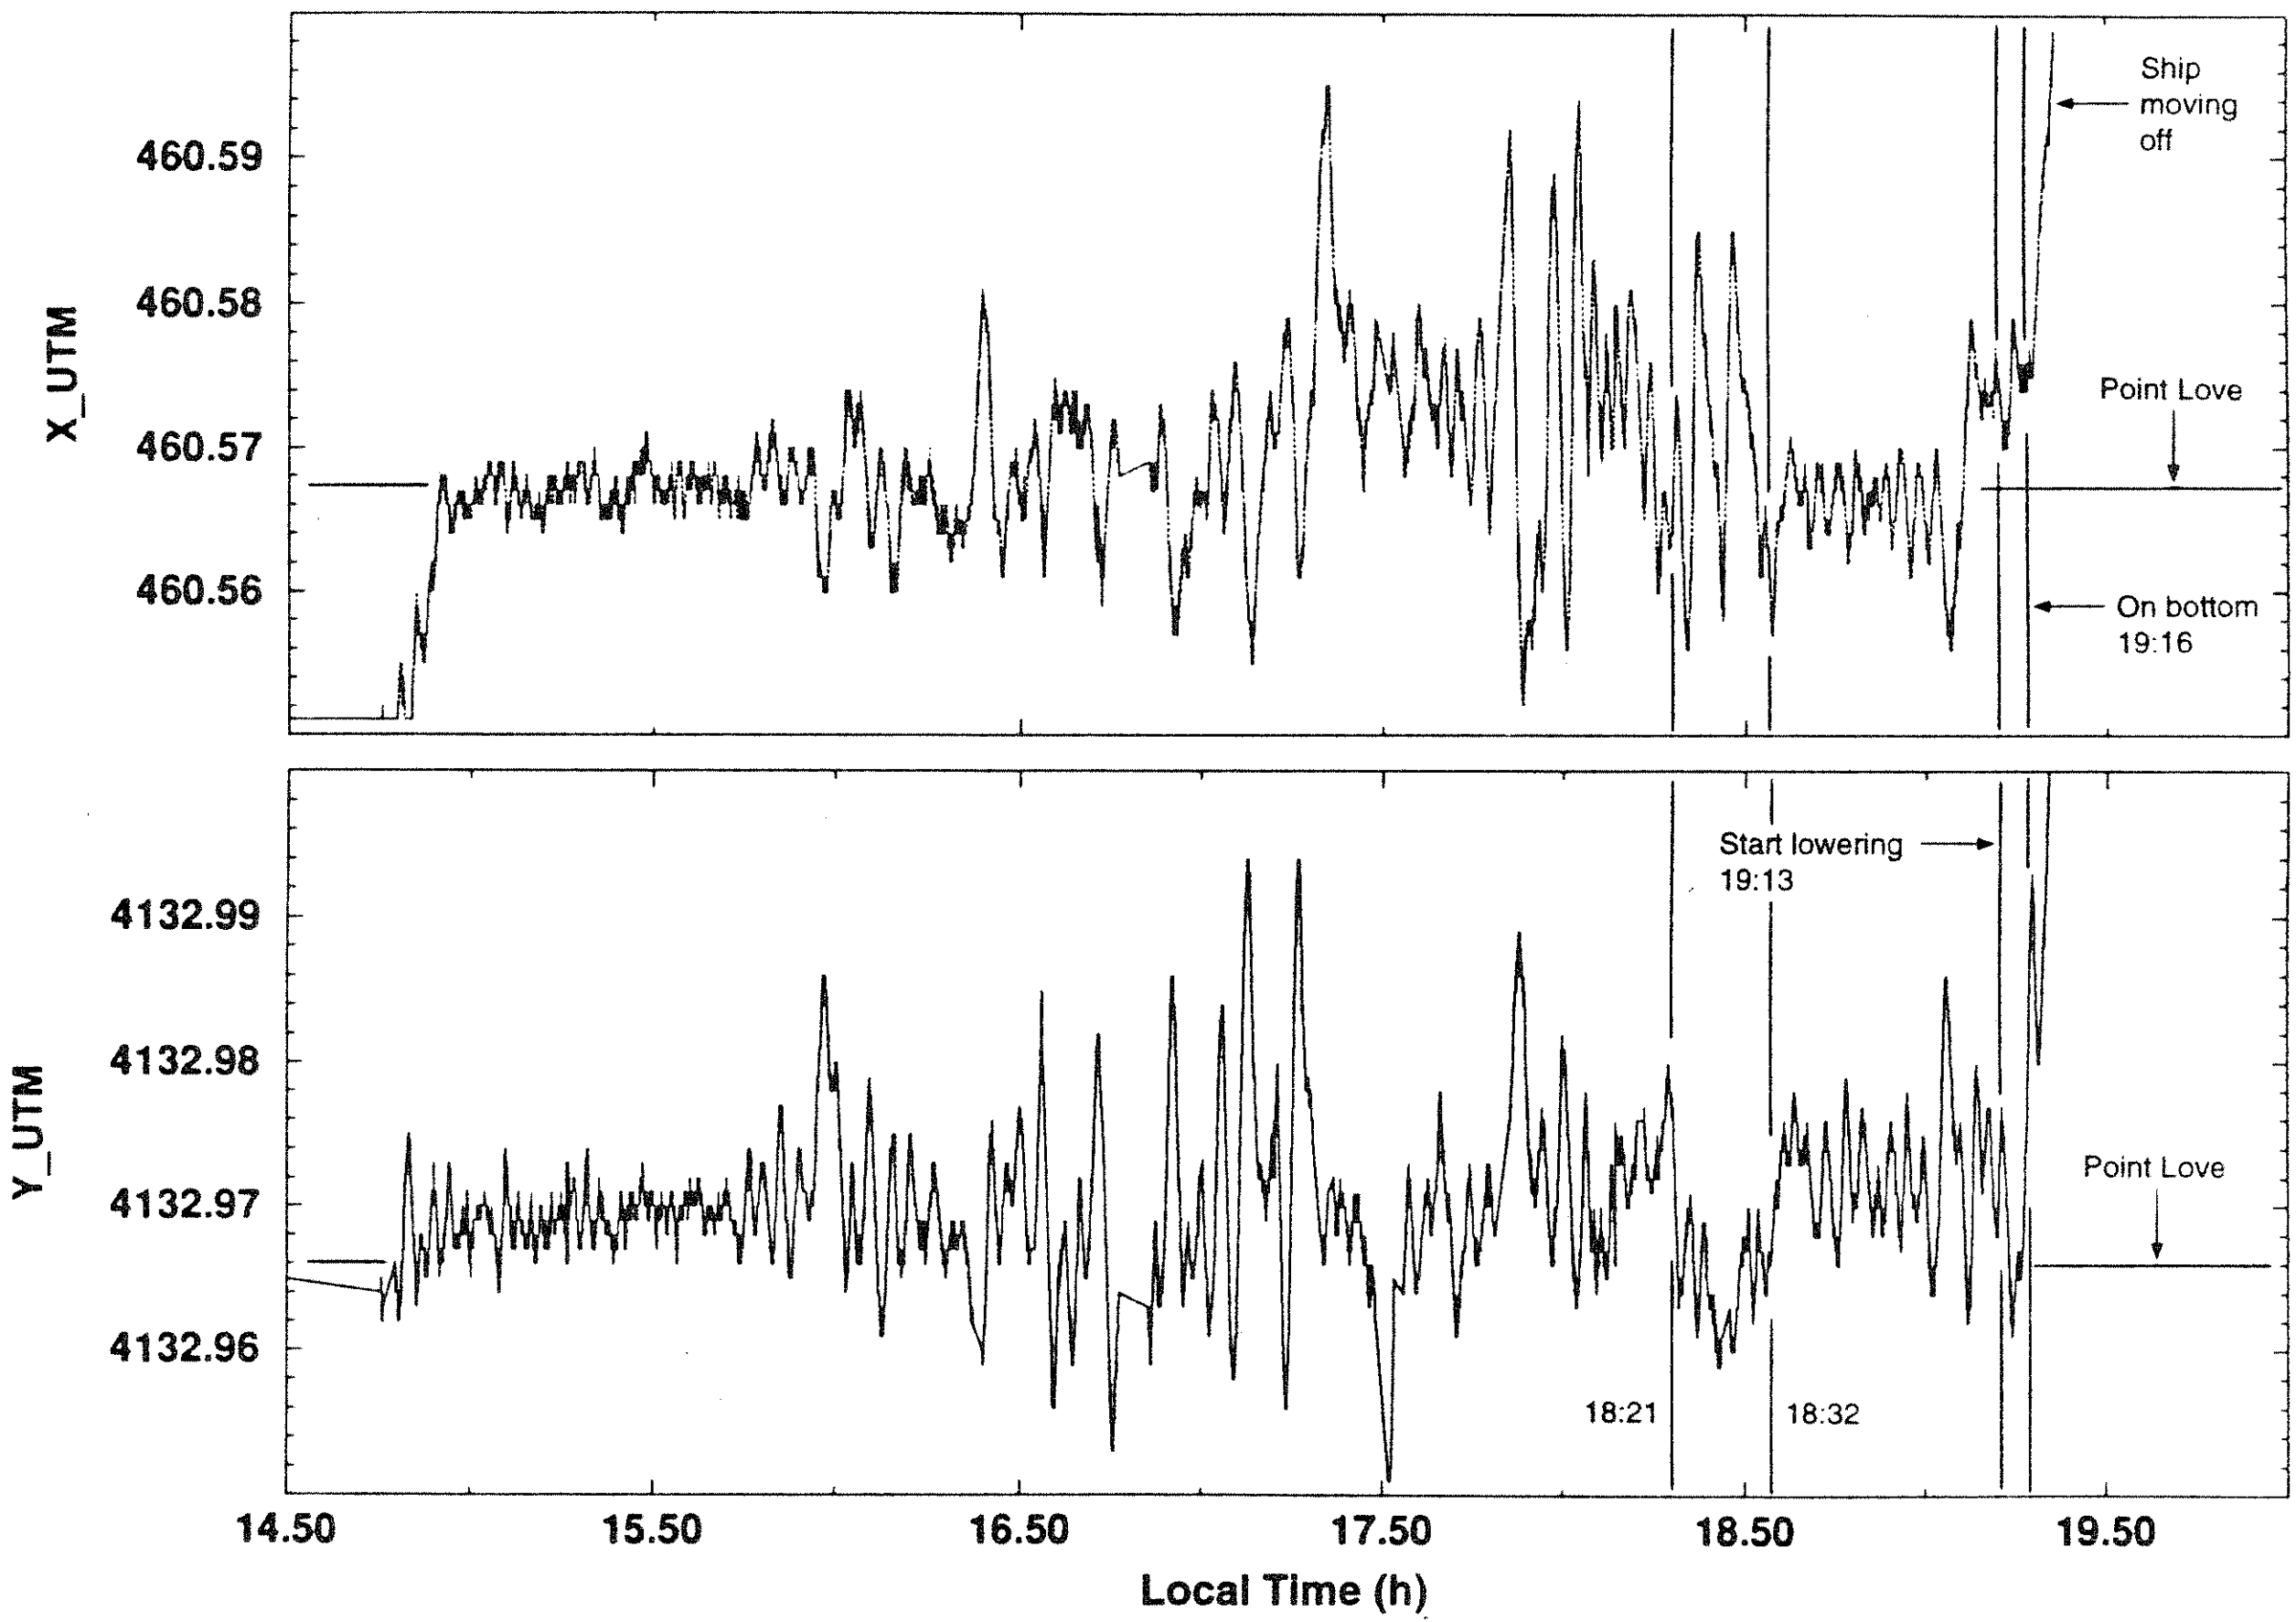
The ship seemed to be holding station quite well between 1832 and 1900 local time. Travel times were steady. Then there was a brief loss of the differential signal, and the ship drifted off slightly. At 1913, the captain said he felt he had the ship back on station in a stable mode, and the order was given to begin lowering the package to the bottom. The descent rate was 0.18 m/s. The descent is obvious in the plots of the acoustic travel times (Figure 22). During this time, the DGPS ship position varied by about 10 m (Figure 21). There was a brief pause of about 1 minute at 925.5 m. The acoustic tilt data and the line tension gave the first indications of touchdown at 1916. The bottom depth was 941 m, based on the pressure-sensor and travel-time data, and the tilt was 5.8°. At this time, about 20 m of cable was payed out, and the ship started to move off to the northeast. This payout was a compromise between having just enough cable to reach the bottom (3 m for stretch in the nylon and 4 m from the top of the structure to the bottom) and paying out enough cable so as to be sure the structure was not pulled horizontally. Thus there is probably 13 m or more of cable on top of or around the source package.

Figure 21. Plot of DGPS ship position data during deployment. The units of the ordinates are kilometers (each tick is 2 m; full scale is 50 m).

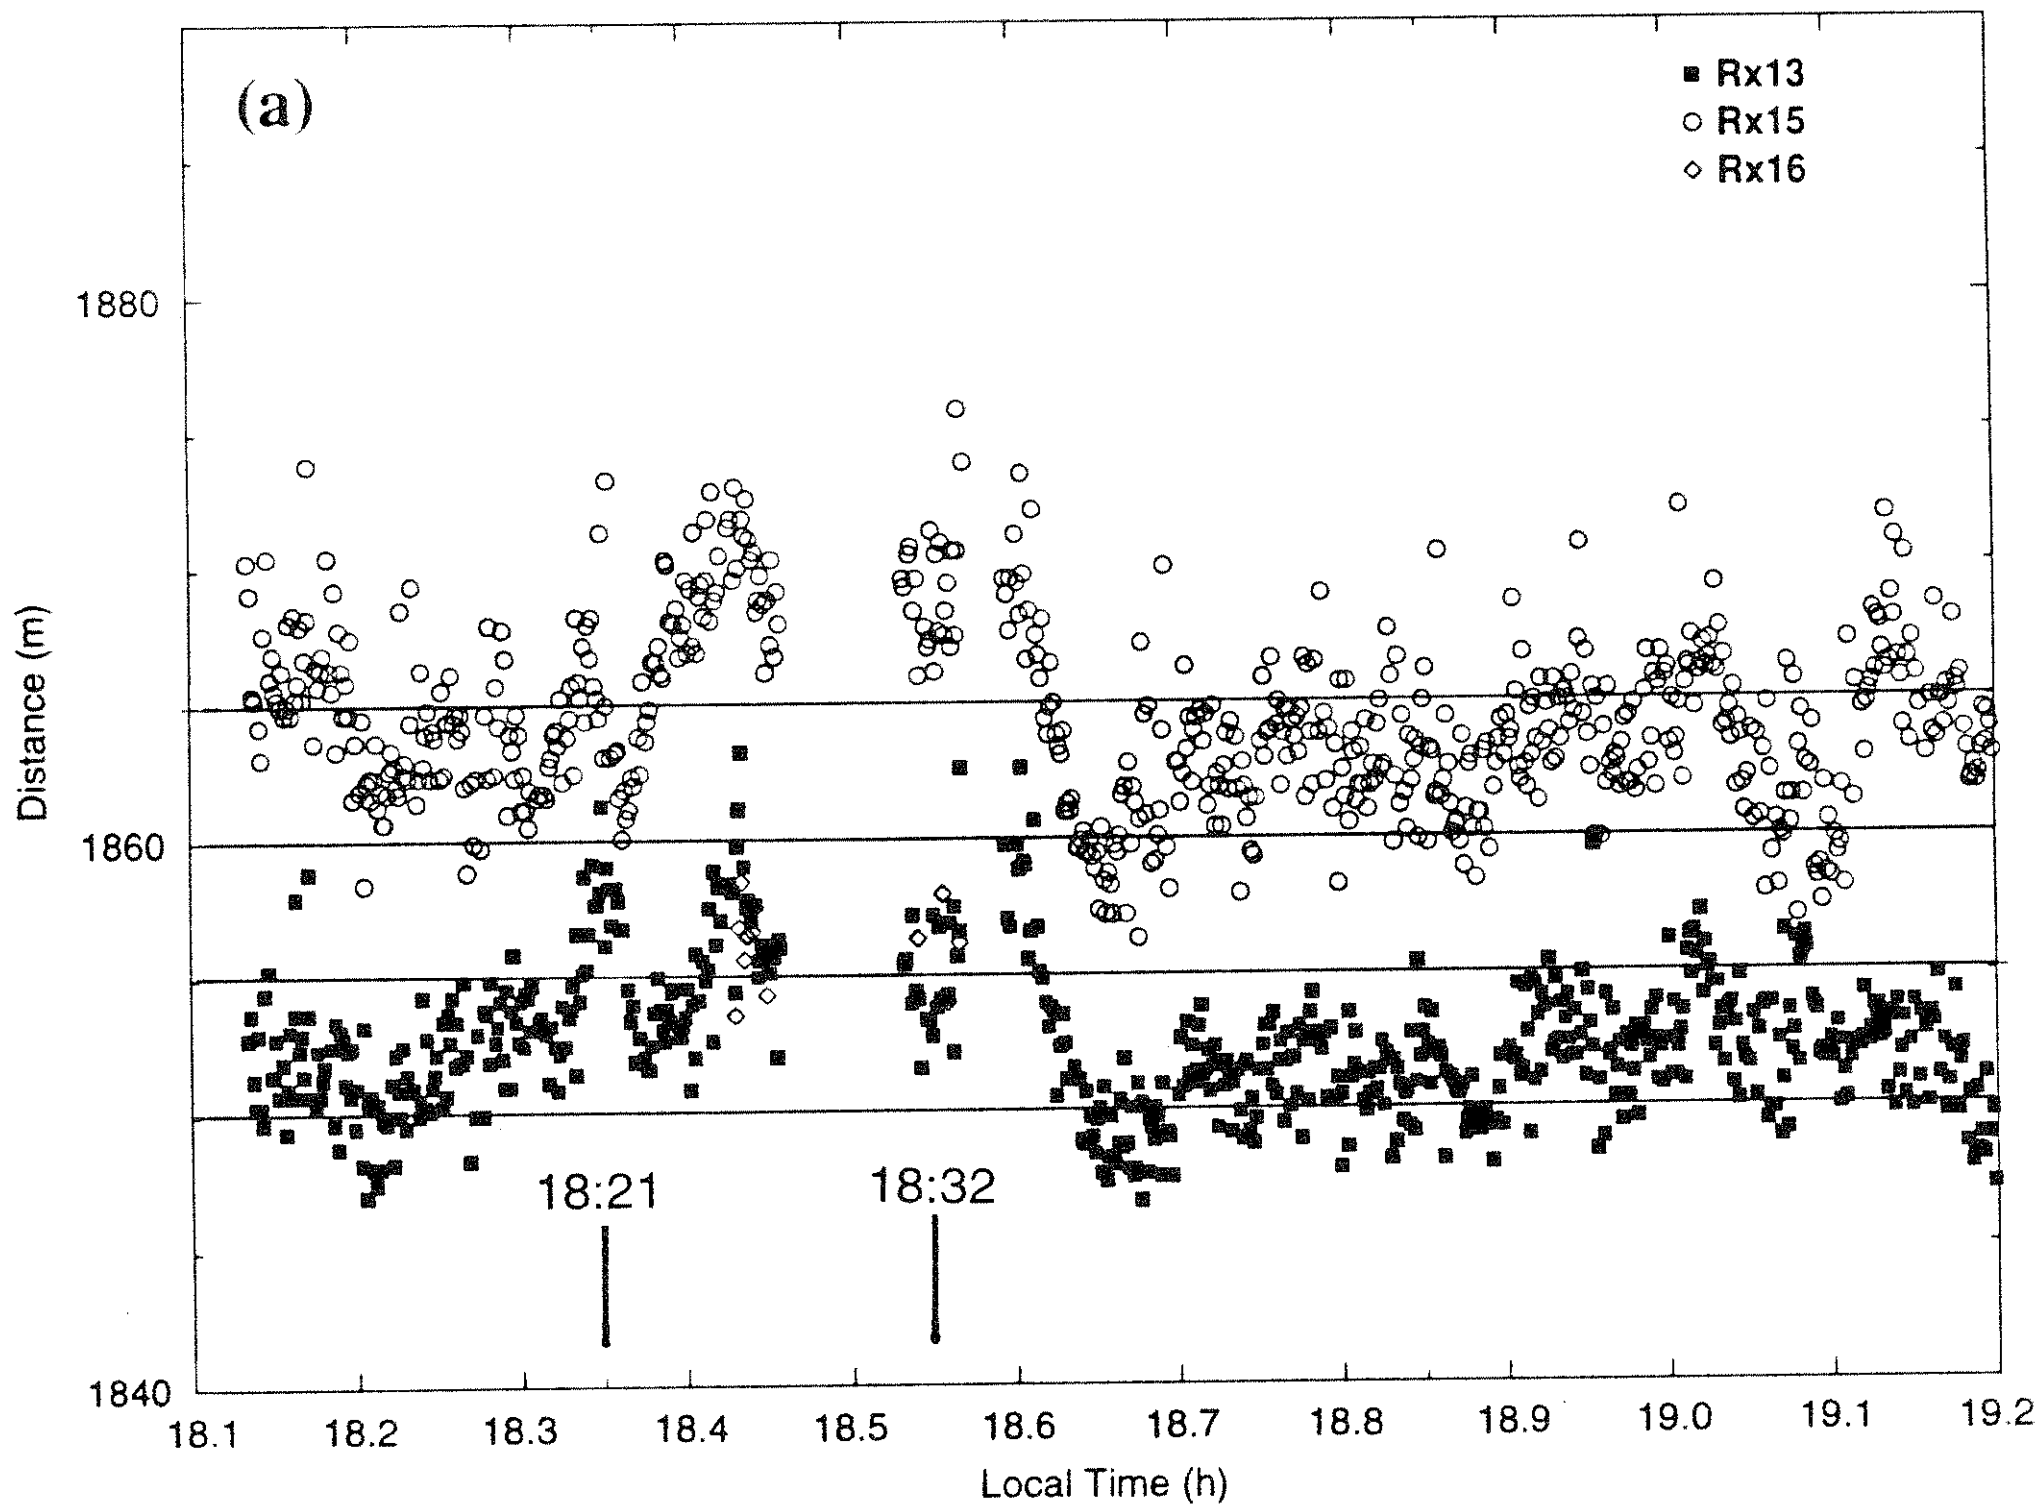
The source was lowered to 914 m and held there approximately 1.5 hours while the navigation was checked. To reduce confusion, it was decided to interrogate and track only the recovery-line release/transponder on the source package. We watched the sing-around travel time (ship to source to T1 to ship) for a minimum travel time. On the echo-sounder, it was possible to see both the source package and the bottom; the latter was at 945 m according to the echosounder. During the afternoon, the DGPS signal was dropping out, and each time the ship would drift off station about 10 m before the DGPS returned (usually in only tens of seconds). It was not possible during the operation to draw any conclusions about the time constant of the source motion, given the small movements of the source. There were no obvious correlations between the measured travel times and the distance of the ship from Point Love. Plots of DGPS ship position and acoustic travel times are shown in Figures 21 and 22, respectively. In the plot of ship position, there is a period of about 1 hour (at the beginning of the plot) when the variation in the positions was only several meters. Later, though, the peak-to-peak variation was as large as 30 m. In the time interval 1821–1832 (local time; 0121–0132 UTC), the excursions were about this much, and the sing-around travel times (in terms of range) show significant deviations of 5–10 m.

Figure 22a. Plots of acoustic tracking data: sing-around ranges prior to deployment (source at 914-m depth).

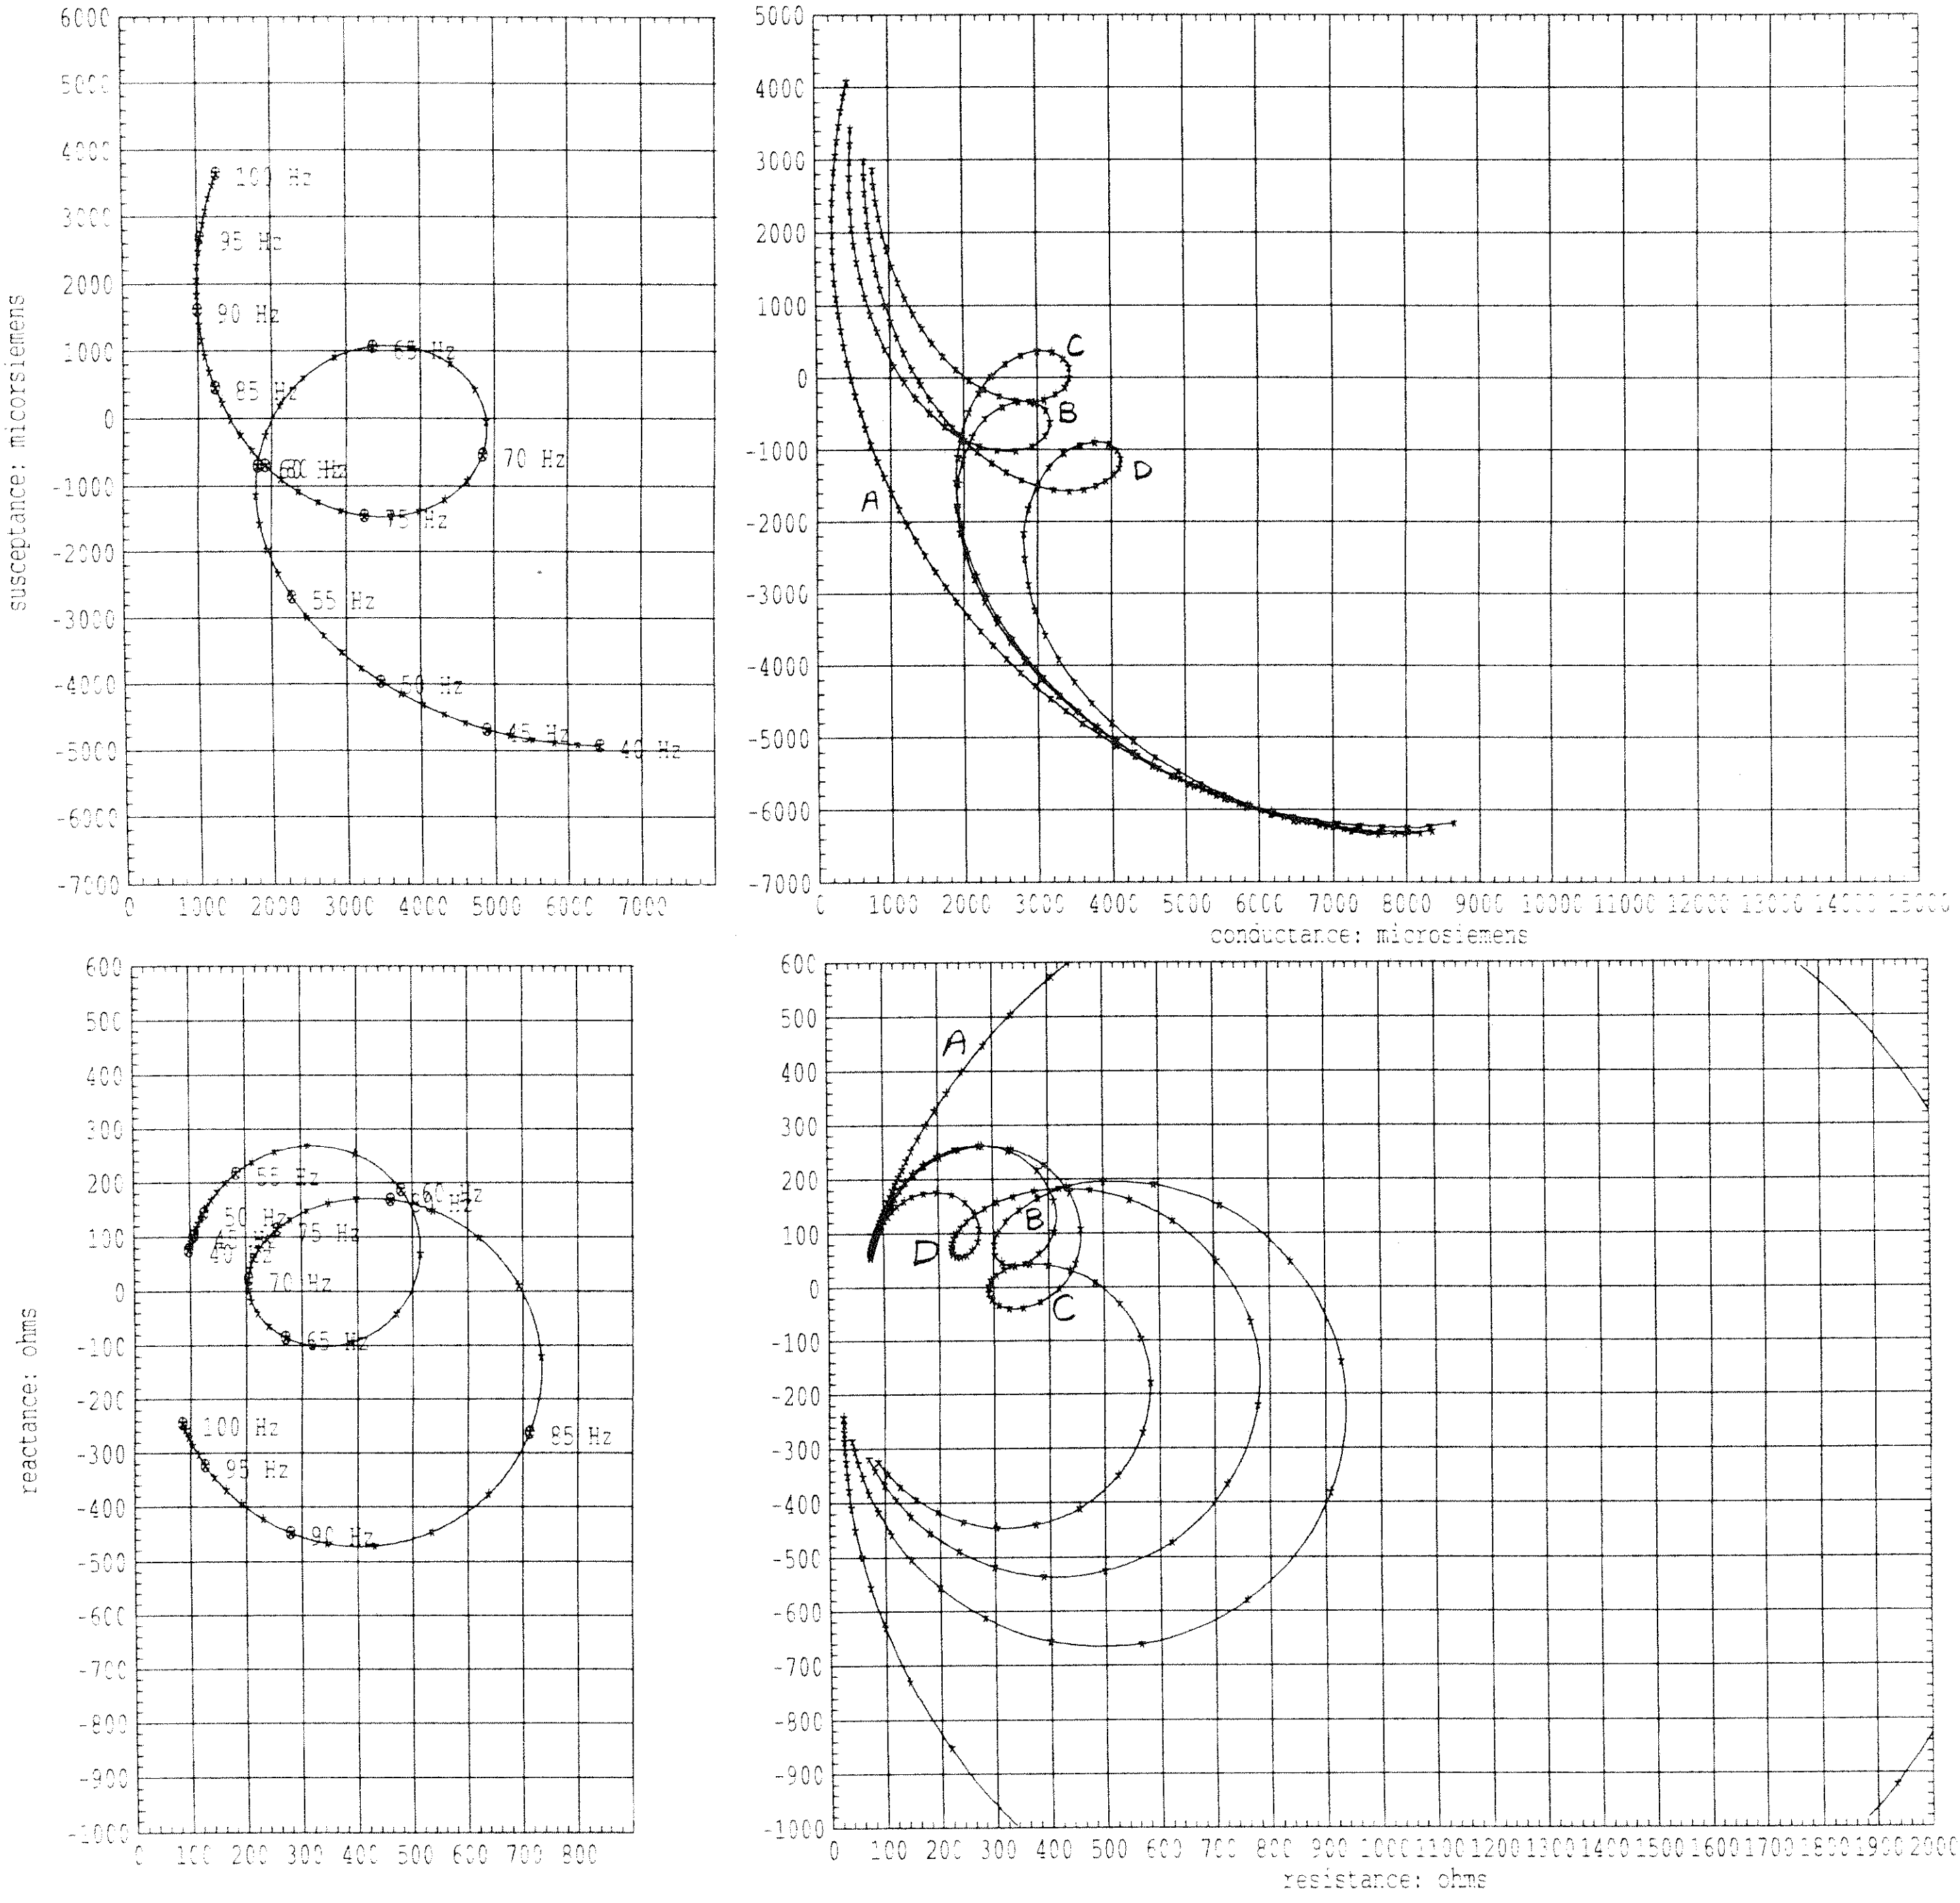
The acoustic signal was sent to actuate the gas valve and pressurize the source at 1944. The source impedance was monitored during this time. The impedance plots were at first changing in the way predicted by Kurt Metzger's model, but then they started to change in an unexpected way. This produced some consternation, to say the least. All indications from the acoustic valve were that it was working (it was turned on several times, and it sent confirming signals). After about 45 minutes, the impedance plots (Figure 24) had stablized. Some of this apparently erratic behavior may be explained by assuming the bubble cloud from the excess gas escaping around the source affected the impedance measurement by changing the mechanical characteristics of the source near its resonance frequency.

Figure 23. Plots of impedance (top) and admittance (bottom) as predicted based on Metzger's model (left) and as measured during pressurization of the source (right). Curves A, B, C, and D were measured at –4, 6, 13, and 22 minutes relative to turning on the gas at 1944 local time.
